Full mouth rehabilitation of a patients with gastro-oesophageal reflux disease - A case report

Preetham Prasad Nittla, Deepak Nallaswamy V*

Department of Prosthodontics, Saveetha Dental College, Chennai, Tamil Nadu, India

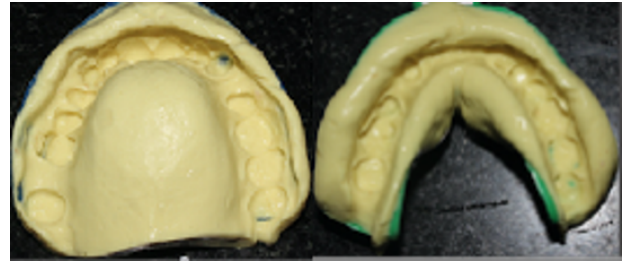
Figure 3: Upper and Lower Alginate impressions made with stock trays

According to the University's Standard Operating Protocol, three sets of diagnostic impressions were made in alginate (Tulip, Cavex, Holland BV) (Figure 3), and stone casts were poured. The diagnostic casts were articulated on a Whip mix 8500 series articulator (Louisville, KY, USA), using Quickmount® face bow (Whip mix, KY, USA) and a centric occlusal wax record. The plan was to restore the OVD by 4mm, thereby allowing for a freeway space of 4 mm, which is within a normal range. To aid in this, a splint was fabricated, which increased the OVD by 4mm. The splint was delivered to the patient, and she was asked to wear it for a period of six weeks. Regular follow up was done to see how the patient adapted to the new OVD. No symptoms were observed, and the increase in OVD was fixed at 4mm. A diagnostic wax-up was then done to plan the anticipated prosthesis and occlusion. Due to erosion and attrition, the loss of tooth structure posed a risk of pulp exposure of few teeth during tooth preparation. Hence, they were intentionally root canal treated before tooth prep could be done (teeth #15, 14, 13, 12, 11, 21, 24, 25, 33, 34, 35, 36, 43, 45, 46 and 47). Cast post and core was deemed necessary in 44 due to a lack of tooth structure. Teeth were prepared (Figure 4) in subsequent appointments, and prefabricated temporary prosthesis were given. In the following visit, the gingival retraction was done using retraction cord (double cord retraction using #000 and #00, Ultrapak®, Ultadent, UT, USA) and a two-stage putty wash impression (Figure 5) (Aquasil, Dentsply, PA, USA) was made for both the jaws. A metal try-in was performed (Figure 6) and verified clinically as well radiographically for fit. Pattern resin jigs were used to determine the final Jaw relation before trial. Master casts were articulated using this interocclusal record, and reconfirmation of the centric was done during the bisque trial stage. Shade selection (B2) was done based on skin complexion and patients choice. Gingival corrective surgery was advised for tooth numbers# 13 and 21, but the patient refused, and so gingival porcelain had to be used instead. The final prosthesis was cemented (Figure 7) using temporary cement (Zinc oxide eugenol cement- DPI), and occlusal equilibration was done. The patient was reviewed after 2 weeks, and the restoration was permanently cemented after a month using Type 1 GIC (GC, Tokyo, Japan).

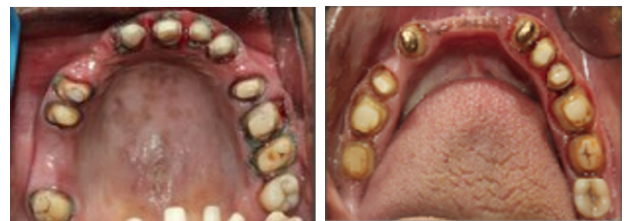
Figure 4: Tooth preparations with Retraction Cords placed prior to impression making

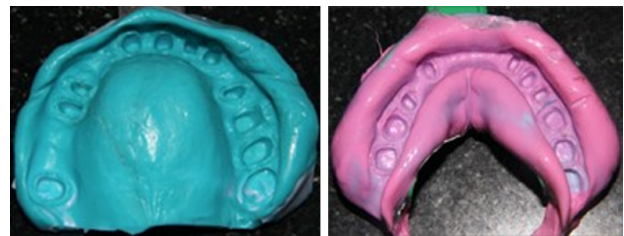
Figure 5: Master impressions (upper and lower)

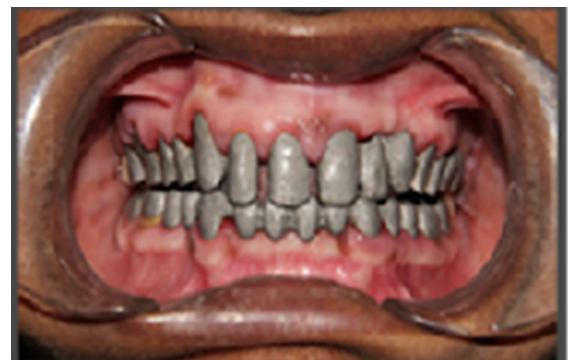
Figure 6: Metal Trial
